Tunnel Water Inflow Recovery by Peter White, P.Eng.

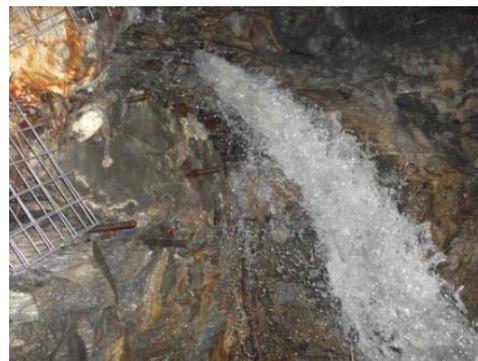
Original water inflow

Grout curtain drill holes were hitting increasing water inflows as the tunnel approached the headpond reservoir. When blasting one of the final rounds in the tunnel, an open fracture was encountered that resulted in a water inflow of 1,500 GPM and flooding of the tunnel face. Tunneling operations were suspended until this water inflow could be stopped.

After the flooded tunnel was dewatered using large pumps, it was observed that the water inflow was entering at the top corner of the tunnel wall through an open fracture measuring approximately 30 cm wide x 60 cm high x 100 cm deep that was connected to the headpond reservoir through various water-bearing fissures.

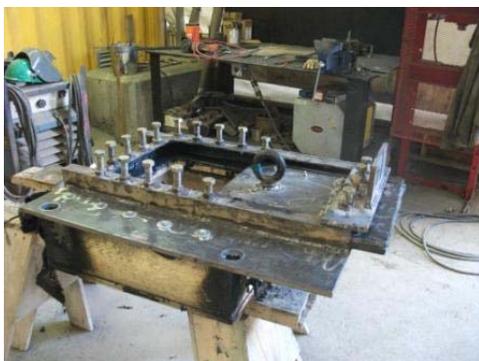
Water control gate fabrication

A water control gate measuring 80 cm x 80 cm was fabricated using 1/2 inch steel plate. An opening measuring 30 cm x 30 cm was cut through the water control gate to allow

A sliding door with door frame and closure bolts was fabricated on the outside face of the water control gate. A wooden frame consisting of 15 cm x 15 cm timbers was attached to the inside face of the water control gate.

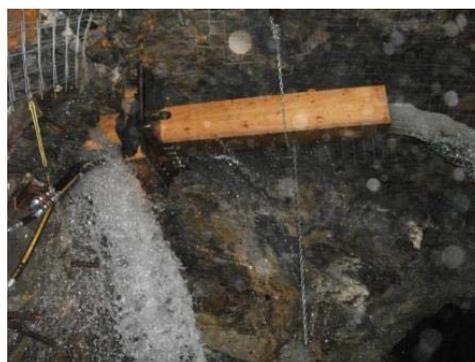
Water control gate and water diversion sluice

The steel water control gate assembly was positioned at the corner of the tunnel wall and was attached to the wall using conventional rock bolts so that the 30 cm x 30 cm opening was aligned directly with the water inflow fracture.

A wooden sluice measuring 2.4 m long was inserted through the opening in the water control gate and into the open fracture to divert the majority of the water inflow away from the water control gate.

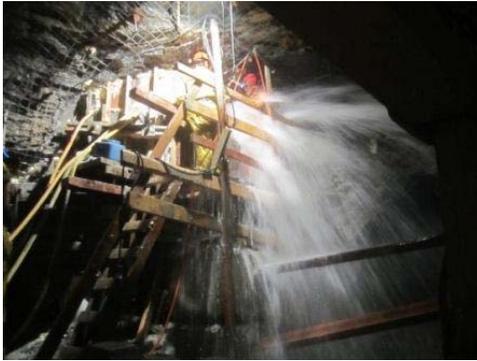
Closing the water control gate

After all preparations had been made, the wooden sluice was removed from the opening and the water control gate was closed and secured in position by closing the tie-down bolts. When the gate was closed, the water inflow was stopped for the first time in over a month.

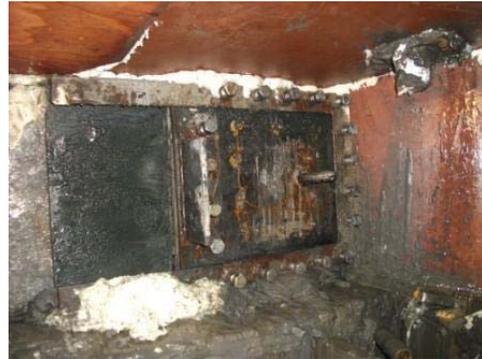
Water control gate in closed position

Grouting operations to fill the water flow pathways behind the water control gate commenced immediately using a thick cement grout with calcium chloride as an accelerator. Grouting pressures were monitored to avoid use of excessive grouting pressure acting on the water control gate.

After pumping 3,000 kg of cement behind the water control gate and into the water-bearing fissures, grouting operations were terminated. Cement grout was allowed to cure for 24 hours before opening the water control gate and removal of concrete formwork.

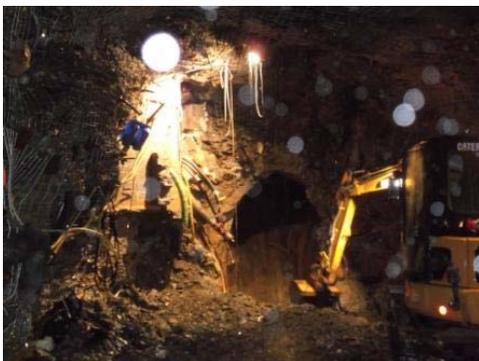
Drilling probe holes

After a month of difficult work to encapsulate the water inflow, a permanent seal was finally achieved. Subsequent probe hole drilling in the area of the original water inflow encountered minimal residual water inflows.

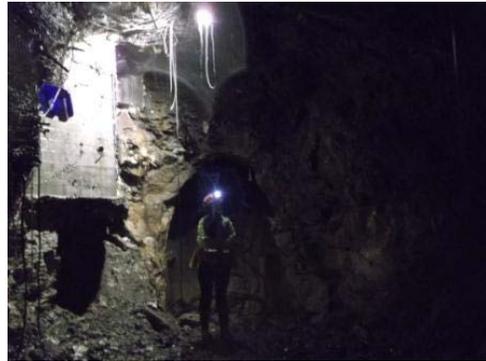
Dry tunnel excavation
