# Overcoming Water Inflow Issues at Sir Adam Beck 1 Generating Station

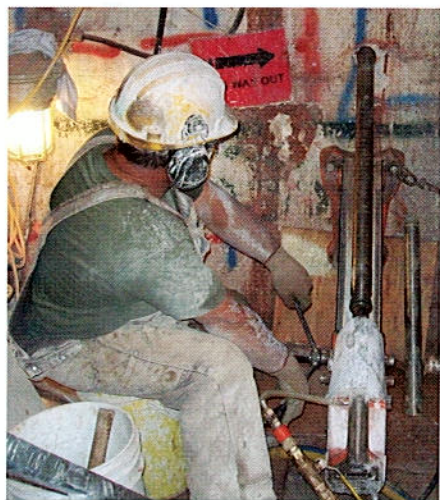
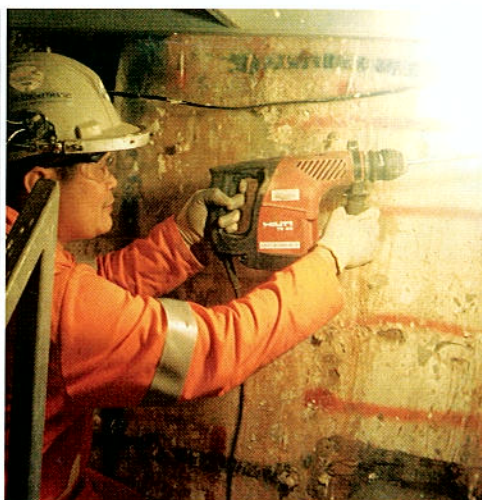
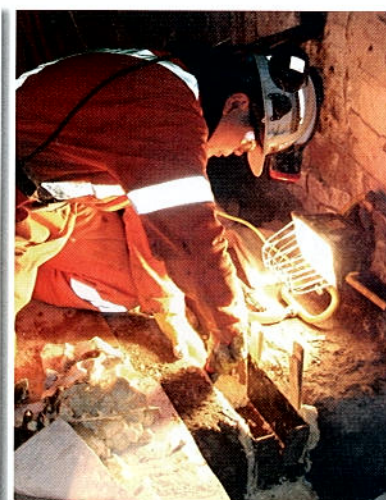
Over time, water inflows began to seep through the brick lining at various locations, leading to corrosion of the support steel for the elevator compartment. Crumbling shale blocked several of the vertical chimney drains and further compounded water inflow problems.

100 cubic metres of water was entering the elevator shaft each day, contributing to wet conditions at the bottom of the elevator shaft and impeding operation of the elevator. OPG engaged the services of Multiurethanes, working in conjunction with Newman Bros and various subtrades, and KGS Group to remedy this situation by reducing water inflows into the elevator shaft.

Grouting work consisted of several stages that included shallow chemical grouting to a depth of 0.6 m, deeper chemical grouting to a depth of 1.2 m, followed by cement grouting with holes drilled to a depth of 4 m. The initial chemical grouting work resulted in an immediate and significant reduction in water inflow entering the shaft although water was subsequently encountered

By the time that all grouting operations had been completed, residual water inflows entering the elevator shaft from all areas had been reduced to less than 30 cubic metres each day, and nuisance water inflow problems from the targeted area had been eliminated.
