Tunnel Water Inflow Recovery

Location: Yukon, Canada

Sector: Tunnels

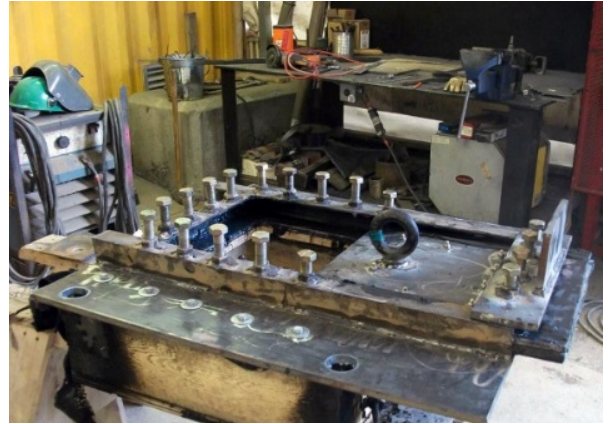
Water control gate fabrication

A water control gate measuring 80 cm x 80 cm was fabricated using 1/2 inch steel plate. An opening measuring 30 cm x 30 cm was cut through the water control gate to allow temporary passage of the 1,500 GPM water inflow.

A sliding door with doorframe and closure bolts was fabricated on the outside face of the water control gate. A wooden frame consisting of 15 cm x 15 cm timbers was attached to the inside face of the water control gate to fill open space between the water control gate and the tunnel rock wall.

Four 25 mm diameter grout hoses were installed directly into the opening and pushed as far as possible into the water-bearing fissures.

The steel water control gate assembly was positioned at the corner of the tunnel wall and was attached to the wall using conventional rock bolts so that the 30 cm x 30 cm opening was aligned directly with the water inflow fracture.

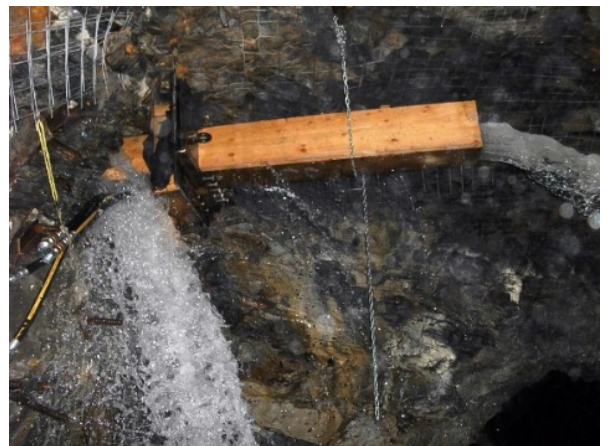
Water control gate and water diversion sluice

A temporary wooden sluice measuring 2.4 m long was inserted through the opening in the water control gate and into the open fracture to divert the majority of the water inflow away from the water control gate.

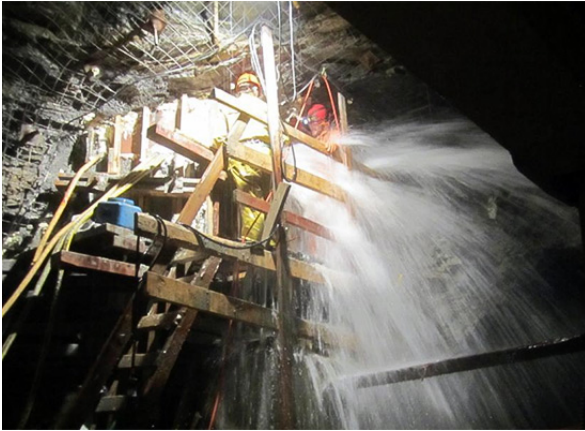
Workers closing a water control gate to stop a 1,500 GPM water inflow

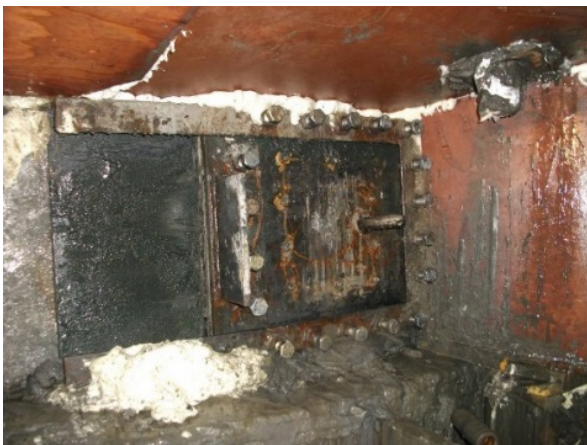
Water control gate in closed position

After all preparations for grouting had been made, the temporary wooden sluice was removed from the opening of the water control gate. The water control door was then closed and secured in position using the tie-down bolts. After the door was closed, the water inflow was stopped for the first time in over a month.

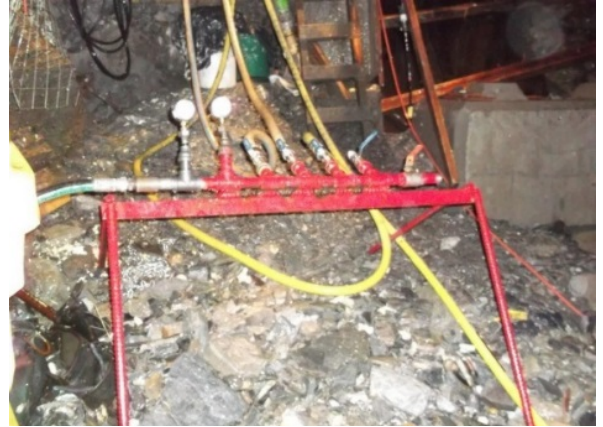
Four-way header for cement grouting

Two cement grout plants were set up adjacent to the water inflow site and a four-way header was assembled to allow all four of the grout hoses behind the water control gate to be grouted at the same time.

Grouting operations commenced immediately using a thick cement grout with calcium chloride as an accelerator. Grouting pressures were monitored to avoid the use of excessive grouting pressure acting on the water control gate.

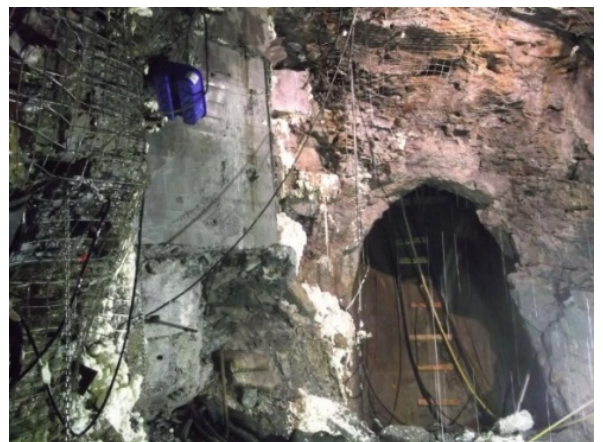
After a month of difficult work to encapsulate the water inflow, a permanent seal was finally achieved. Subsequent probe hole drilling in the area of the original water inflow encountered minimal residual water inflows.

Dry tunnel excavation
