GROUTING AND SHAFT SINKING THROUGH WATER-BEARING GROUND

Abstract

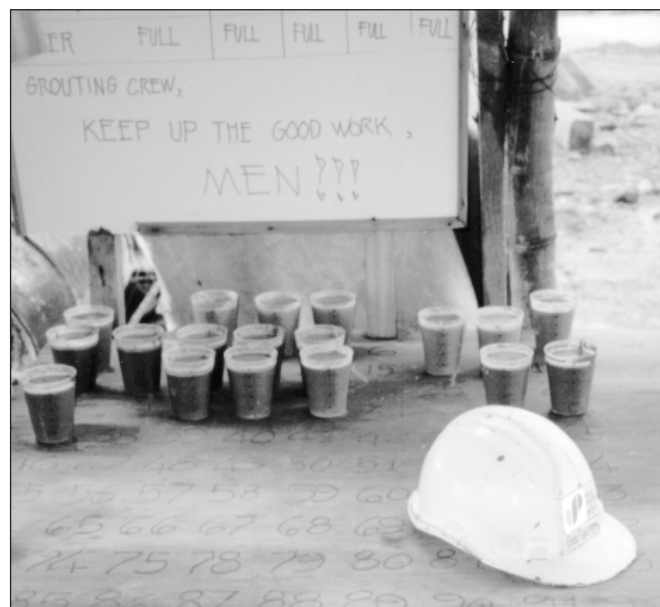
FIGURE 9 - QUALITY CONTROL STATION

A quality control station was established adjacent to the colloidal mixer and each batch of grout was routinely sampled for various performance measurements (S.G., Marsh flow time, bleed) and to monitor the rate of curing, as shown in Figure 9.
