Shaft Collar Construction Through Quicksand Ground Conditions

Location: **Ontario, Canada**

Sector: **Mines**

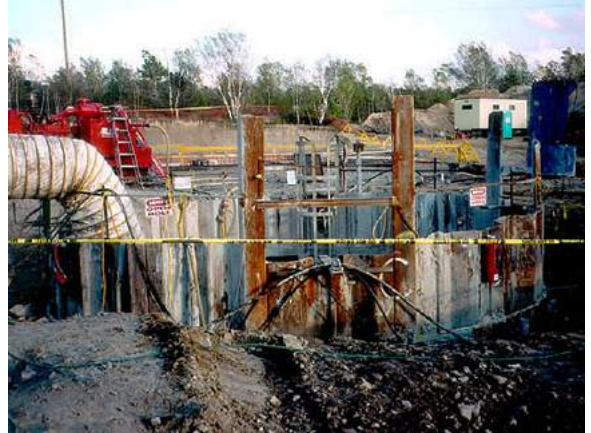
Shaft Collar with sheet piles

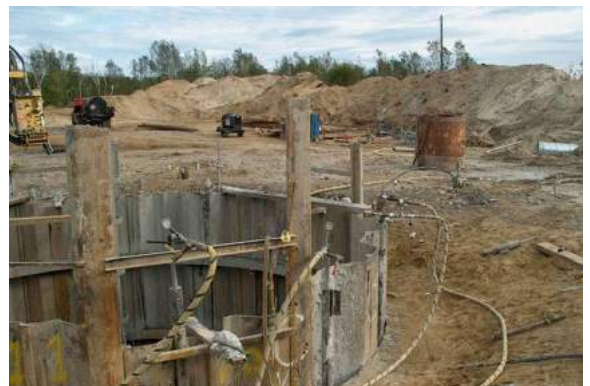
Cement grouting through external grout pipes

The contractor then installed 2 inch diameter steel pipes adjacent to the sheet piles and undertook cement grouting to construct a grouted toe at the interface between the sheet piles and underlying rock. This cement grouting program provided sufficient improvement to the surrounding ground conditions to enable the shaft to be excavated down to the top of the sloping rock interface.

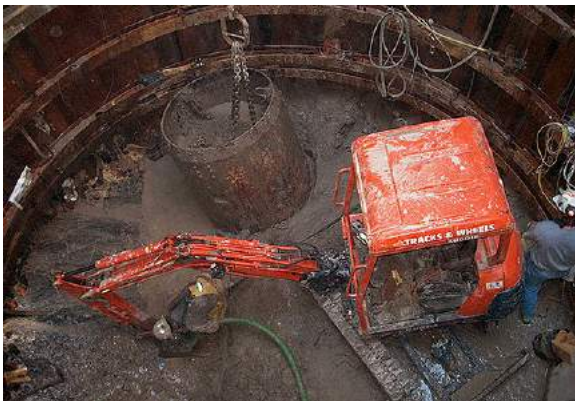
Quicksand inflow at the bottom of the shaft
