# Large-Scale Cement Grouting for Forrest Kerr Cofferdam Construction

Location: **Forrest Kerr, British Columbia**

Sector: **Dams**

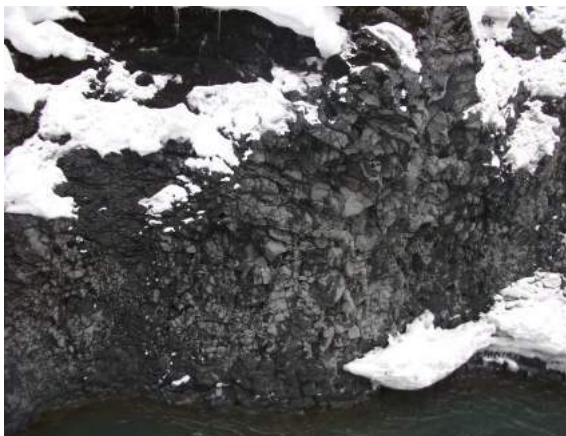
*Porous rock formation beneath cofferdam*

AltaGas requested Peter White to direct cement grouting operations on an urgent basis to consolidate porous foundation conditions beneath a sheet pile cofferdam prior to seasonal flooding of the Iskut River and Forrest Kerr Creek.

A local drilling contractor was retained to provide crews and Davey Kent DK725 duplex drilling equipment to install steel casing into the porous foundation rocks beneath the sheet pile cofferdam.

Drilling commenced along the cofferdam alignment with widely spaced primary holes, drilled to shallow depths of a few meters. Drilling stopped and cement grouting commenced whenever difficult ground conditions were encountered or when drillers would lose circulation through underground fissures or cavities.

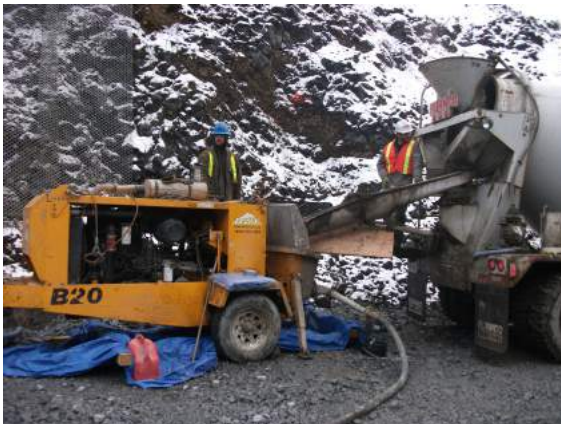
*Mayco B20 concrete pump in operation*

Small portable concrete pumps were provided for undertaking cement grouting operations. The contractor provided both Reed B20 and Mayco LS30 concrete pumps with 2-inch diameter concrete hose.

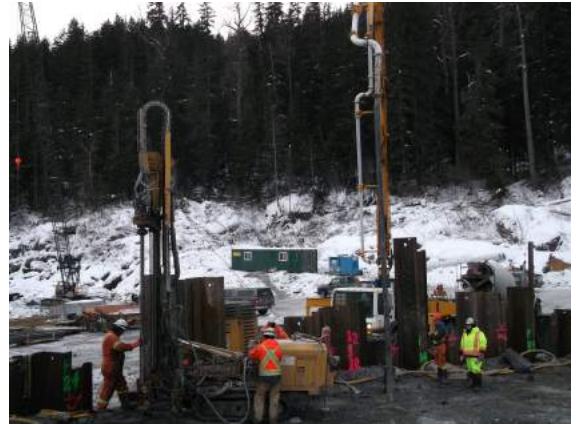
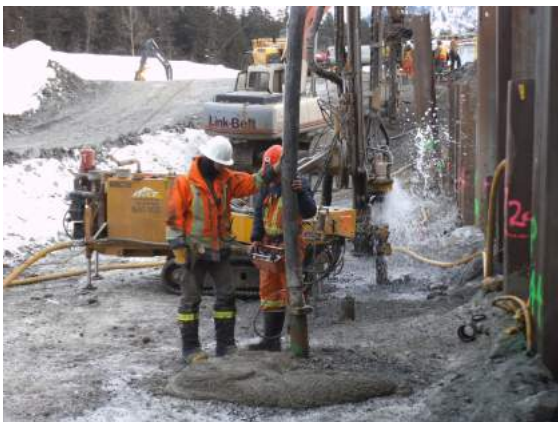
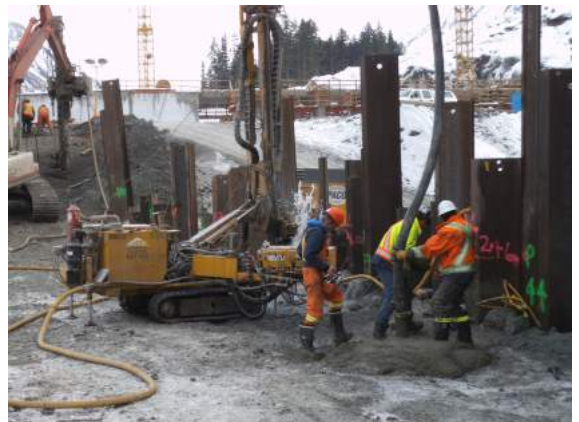
*Drilling and grouting at Stage 2 cofferdam*

The following winter, similar grouting techniques were implemented to consolidate broken ground conditions beneath the Stage 2 cofferdam to facilitate construction of downstream diversion gates across the river bottom adjacent to the original cofferdam.

This work involved more than 30 holes sequentially drilled and grouted using down-stage methods to ultimate depths exceeding 12 m and consumed approximately 300 cubic meters of cement grout over a span of 2 weeks.

For Stage 2 cofferdam grouting work, a concrete boom pump was utilized to facilitate placement of cement grout into drilled holes.
