# Large-Scale Cement Grouting for Forrest Kerr Cofferdam Construction

Location: **Forrest Kerr, British Columbia**

Sector: **Dams**

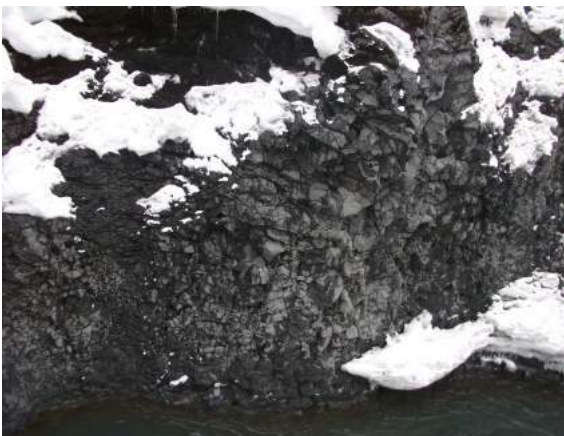
*Porous rock formation beneath cofferdam*

As project construction was underway, AltaGas, owner of Forrest Kerr hydro project, became concerned that complex geological conditions underlying the headworks sheet pile cofferdam could lead to flooding during high water level conditions and jeopardize construction of the de-sanding basin and associated headworks structures.

AltaGas requested Peter White to direct cement grouting operations on an urgent basis to consolidate porous foundation conditions beneath a sheet pile cofferdam prior to seasonal flooding of the Iskut River and Forrest Kerr Creek.

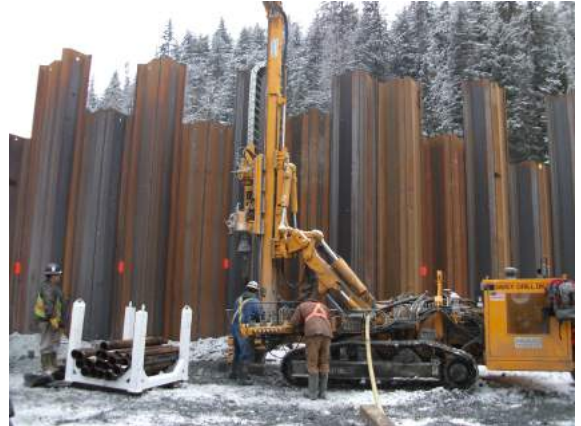
*Drilling grout holes adjacent to cofferdam*

A local drilling contractor was retained to provide crews and Davey Kent DK725 duplex drilling equipment to install steel casing into the porous foundation rocks beneath the sheet pile cofferdam.

Drilling commenced along the cofferdam alignment with widely spaced primary holes, drilled to shallow depths of a few meters. Drilling stopped and cement grouting commenced whenever difficult ground conditions were encountered or when drillers would lose circulation through underground fissures or cavities.

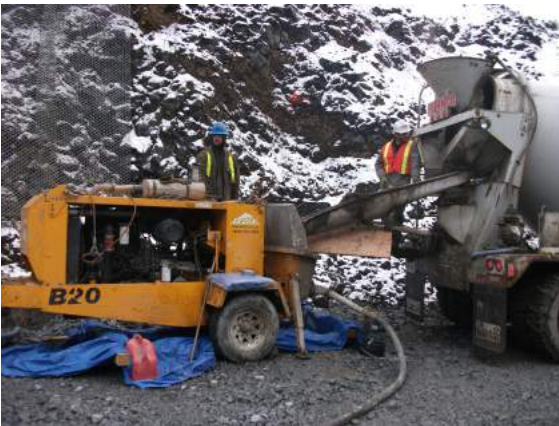
*Mayco B20 concrete pump in operation*

Small portable concrete pumps were provided for undertaking cement grouting operations. The contractor provided both Reed B20 and Mayco LS30 concrete pumps with 2-inch diameter concrete hose.

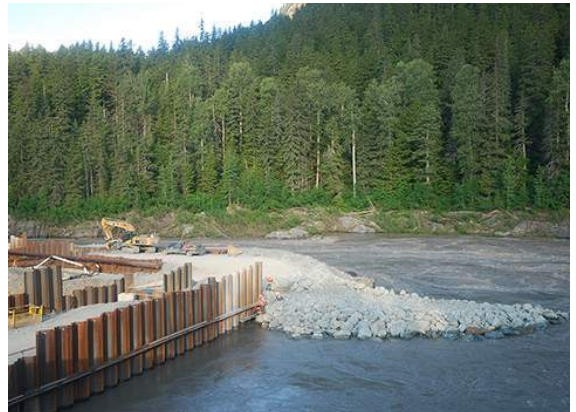
*Iskut River during summer high water flood stage*

The completed cofferdam was successful in holding back high river water flows during the summer months, enabling headworks construction to be completed as scheduled.

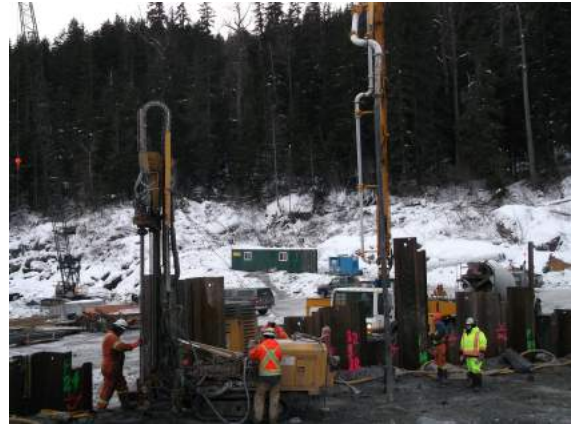
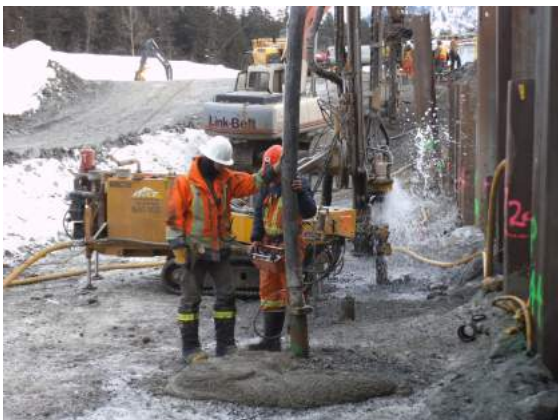
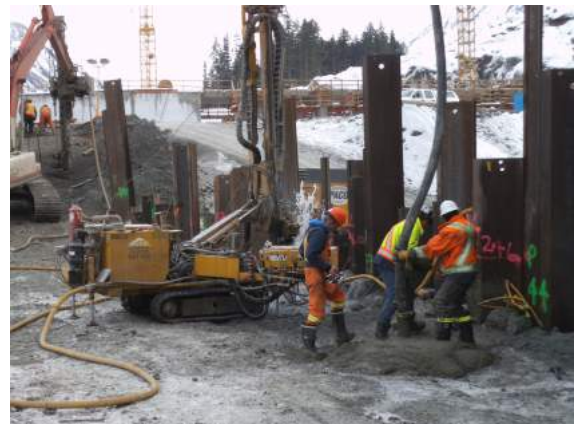
*Drilling and grouting at Stage 2 cofferdam*

The following winter, similar grouting techniques were implemented to consolidate broken ground conditions beneath the Stage 2 cofferdam to facilitate construction of downstream diversion gates across the river bottom adjacent to the original cofferdam.

This work involved more than 30 holes sequentially drilled and grouted using down-stage methods to ultimate depths exceeding 12 m and consumed approximately 300 cubic meters of cement grout over a span of 2 weeks.

For Stage 2 cofferdam grouting work, a concrete boom pump was utilized to facilitate placement of cement grout into drilled holes.
