## Water Cutoff in Raise Bore Pilot Hole

Location: Red Lake, Ontario

Sector: Mining

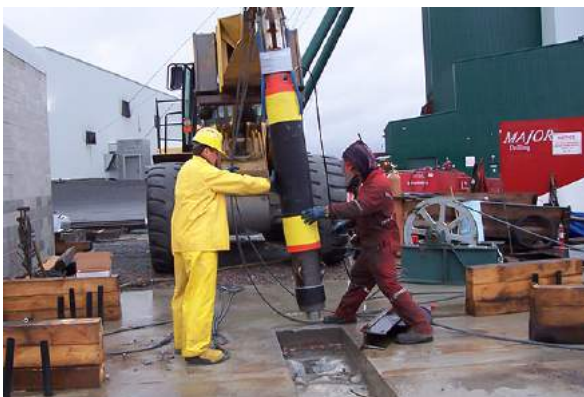
280 mm diameter inflatable packer assembly installation at collar of pilot hole

To prepare for drilling and grouting operations, a 280 mm diameter inflatable packer was installed at a depth of 133 m to stop water from flowing down the 380 mm diameter pilot hole. This packer enabled drilling and grouting work to proceed under static water conditions with no residual flow.

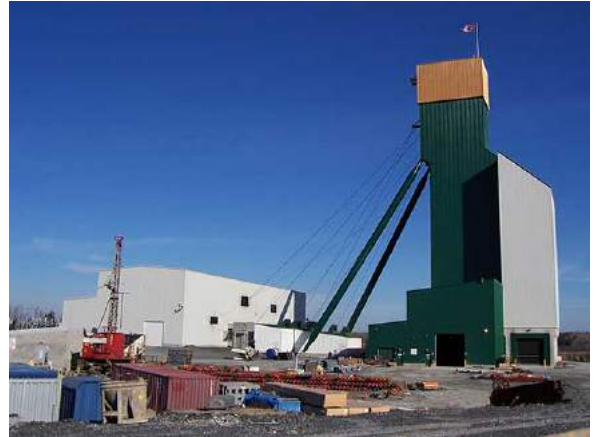
Project site with pilot hole situated beneath diamond drill (shown on left)

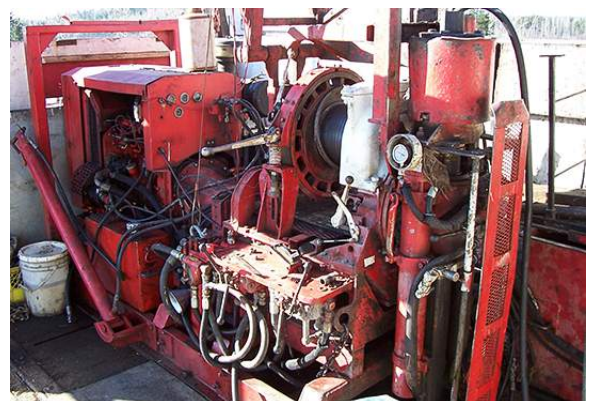
Diamond drill holding HQ drill rods

To support the estimated 17,000 kg load, a combination of HQ drill rods and 3/4 inch diameter non-rotating steel safety cable was selected to provide an adequate factor of safety.

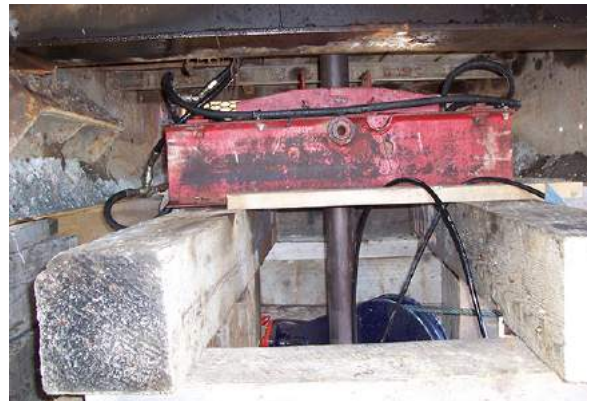
*Foot clamp holding HQ drill rods*

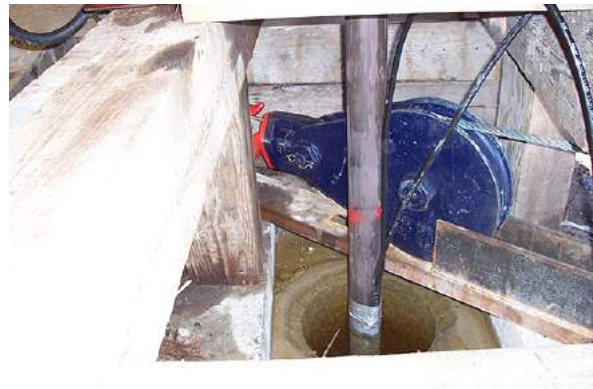
*Sheave wheel for 3/4 inch safety cable at collar of drill hole with packer inflation hoses attached to HQ drill rods*

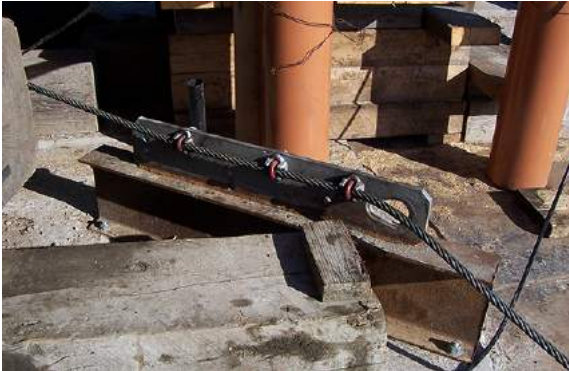
*Deadman anchor used to hold 3/4 inch safety cable*

A deadman bracket was attached to the concrete foundation for the raise bore machine with cable clamps installed to hold the safety cable.

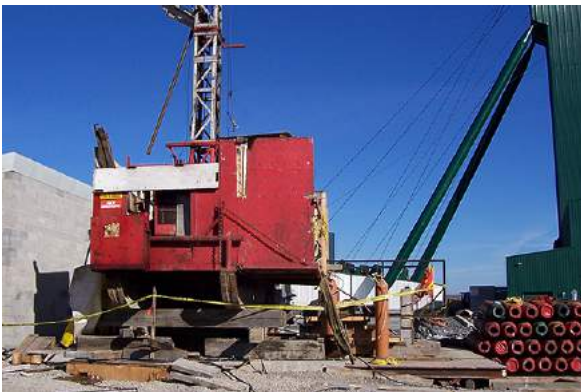
*Diamond drill elevated above pilot hole collar*

A large diamond drill equipped to handle HQ rods was positioned over the pilot hole and elevated approximately one meter above collar elevation with wooden cribbing to provide for personnel access and adequate working space beneath the drill rig at the collar of the drill hole.

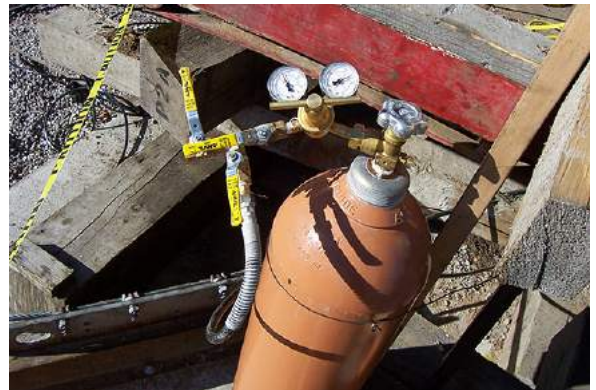
*Nitrogen tank with regulator for inflating packers*

Inflation hoses were connected to individual nitrogen tanks and regulators. The 280 mm packer was inflated to complete packer installation within the pilot hole. The 57 mm packer was inflated to close the internal 3-inch drain pipe and prevent groundwater from flowing down the hole.

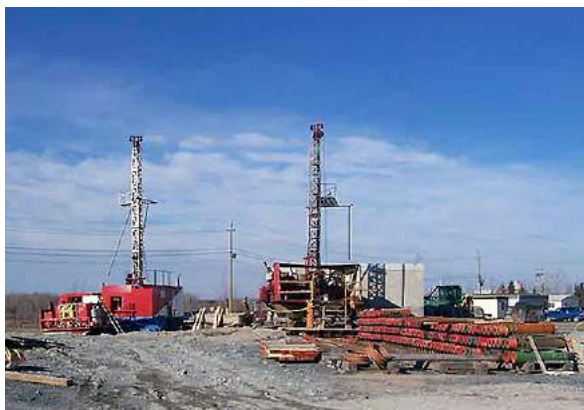
*Drilling NQ grout holes in proximity to pilot hole*

Drill hole collars were located 12 m away from the pilot hole. Drill holes were aligned to intercept the water flow fracture approximately 7 m away from the pilot hole. Each drill hole was gyro-surveyed after completion of drilling to confirm actual intercept location.
