Ground Improvement for Ventilation Raise Construction

Location: **Halmahera, Indonesia**

Sector: **Mining**

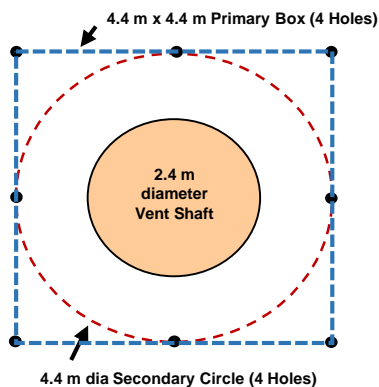
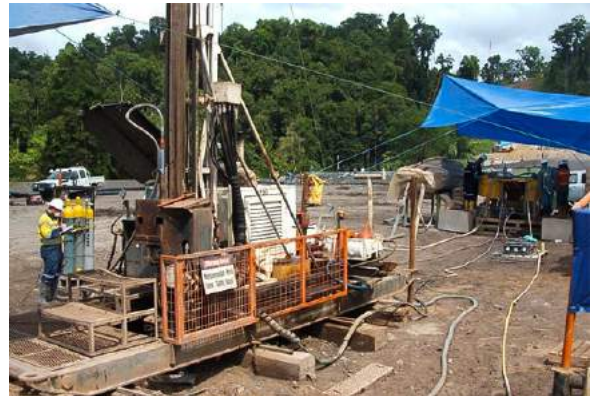
Diamond drill in foreground, grout plant in background

All drilling and in-hole activities (packer positioning and flushing operations) were undertaken using a Boart LM 75 drill rig. Drilling productivity typically ranged between 15 m to 20 m of HQ drill hole each shift. HQ drill rods were handled using an integral rod handling system. BQ drill rods for flushing and grouting were manually handled on/off the drill rig.

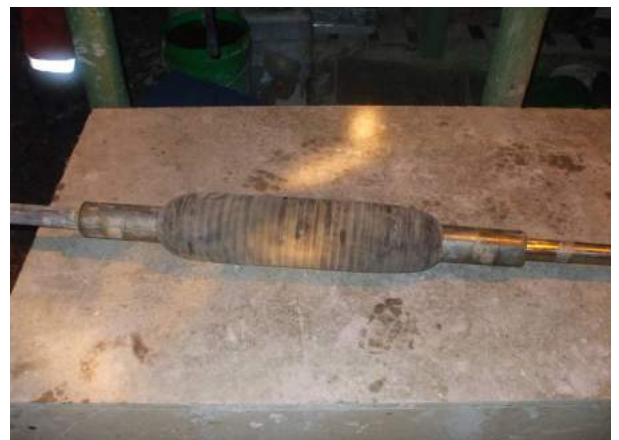
Inflatable packer showing fixed head (left), inflated gland and sliding head (right)

For grouting work in HQ drill holes (96 mm dia.), inflatable packers of 73 mm diameter were used, with maximum allowable inflation pressures up to 60 bar and typical inflation pressures up to 40-50 bar.

Two inflatable packers burst while being inflated down-hole. In both cases, insufficient care was taken to set the packer at a suitable location within solid rock, so the packer gland deformed within an oversized portion of the drill hole and burst while inflating. A third inflatable packer was used without incident for the balance of the project duration.

Packers were inflated using inert nitrogen gas regulator assemblies. Inflation hoses consist of a reel-mounted, 3,000 psi, 6 mm inside diameter, 100R2 hydraulic hose attached to a short length of 3,000 psi, 3 mm inside diameter, 100R2 hydraulic hose that was connected to the inflatable packer.

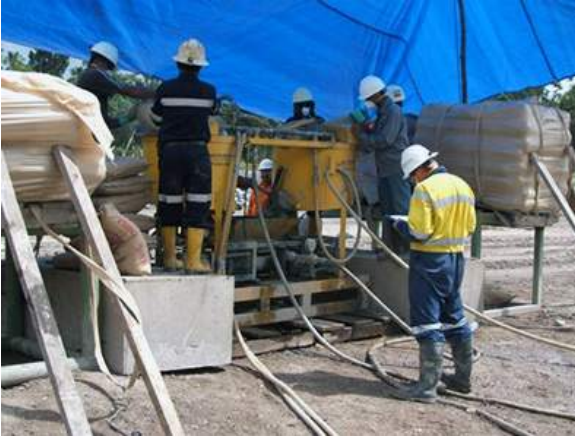
Typical grout plant setup at surface

Cement grout plant was operated with compressed air and consisted of two 265 liters paddle mix tanks supplying cement grout to a 75 mm diameter duplex plunger pump.

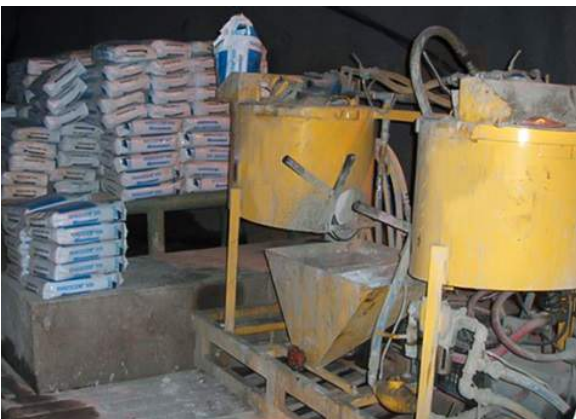
Typical grout plant setup underground
