# Large-Scale Cement Grouting for Forrest Kerr Cofferdam Construction

📍 Location: **Forrest Kerr, British Columbia**

🏗️ Sector: **Dams**

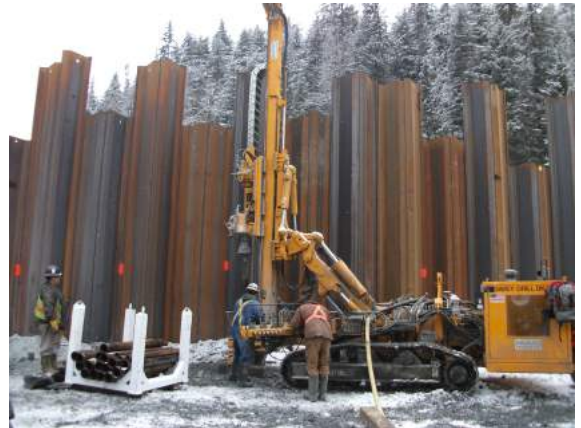
*Drilling grout holes adjacent to cofferdam*

A local drilling contractor was retained to provide crews and Davey Kent DK725 duplex drilling equipment to install steel casing into the porous foundation rocks beneath the sheet pile cofferdam.

Drilling commenced along the cofferdam alignment with widely spaced primary holes, drilled to shallow depths of a few meters. Drilling stopped and cement grouting commenced whenever difficult ground conditions were encountered or when drillers would lose circulation through underground fissures or cavities.

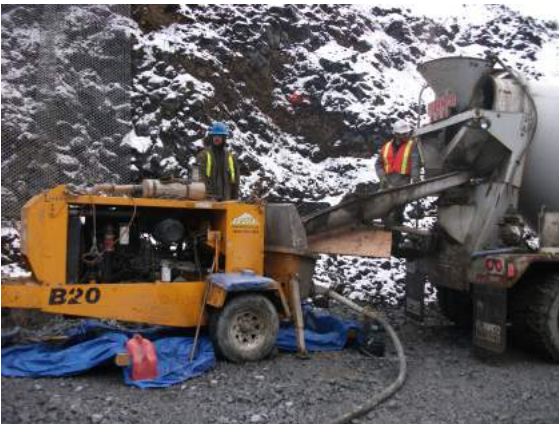
*Mayco B20 concrete pump in operation*

Small portable concrete pumps were provided for undertaking cement grouting operations. The contractor provided both Reed B20 and Mayco LS30 concrete pumps with 2-inch diameter concrete hose.

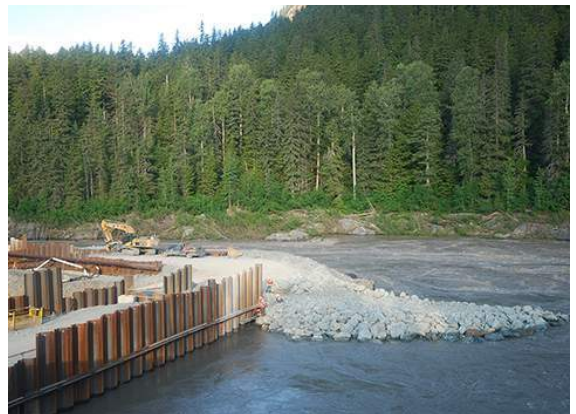
*Iskut River during summer high water flood stage*

The completed cofferdam was successful in holding back high river water flows during the summer months, enabling headworks construction to be completed as scheduled.

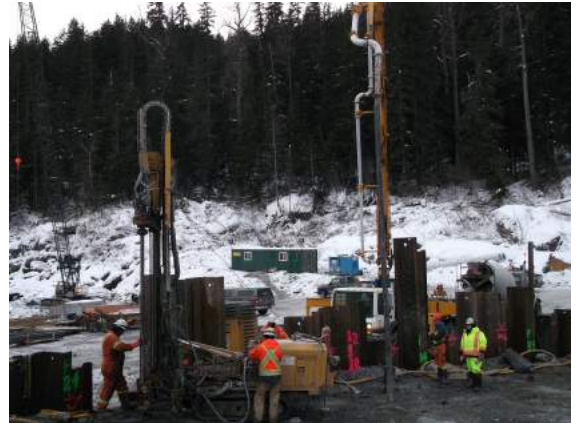
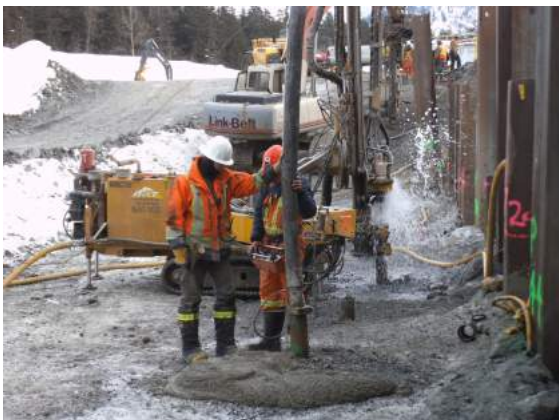
*Drilling and grouting at Stage 2 cofferdam*

The following winter, similar grouting techniques were implemented to consolidate broken ground conditions beneath the Stage 2 cofferdam to facilitate construction of downstream diversion gates across the river bottom adjacent to the original cofferdam.

This work involved more than 30 holes sequentially drilled and grouted using down-stage methods to ultimate depths exceeding 12 m and consumed approximately 300 cubic meters of cement grout over a span of 2 weeks.

For Stage 2 cofferdam grouting work, a concrete boom pump was utilized to facilitate placement of cement grout into drilled holes.
