Shaft Collar Construction Through Quicksand Ground Conditions

Location: **Ontario, Canada**

Sector: **Mines**

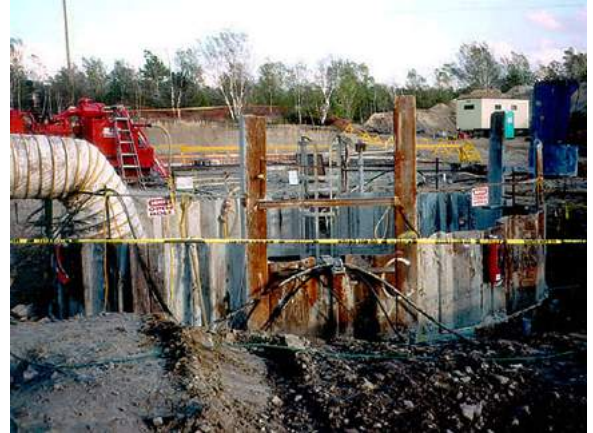
Shaft Collar with sheet piles

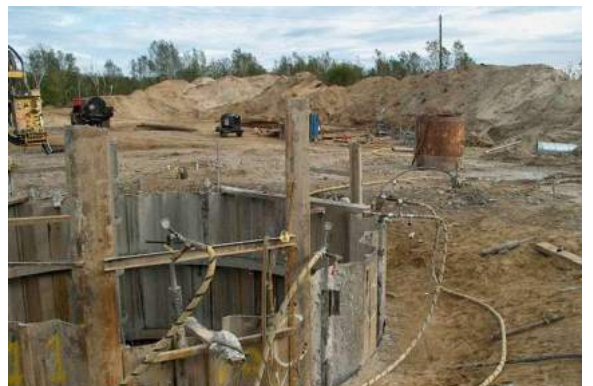
Cement grouting through external grout pipes

The contractor then installed 2 inch diameter steel pipes adjacent to the sheet piles and undertook cement grouting to construct a grouted toe at the interface between the sheet piles and underlying rock. This cement grouting program provided sufficient improvement to the surrounding ground conditions to enable the shaft to be excavated down to the top of the sloping rock interface.

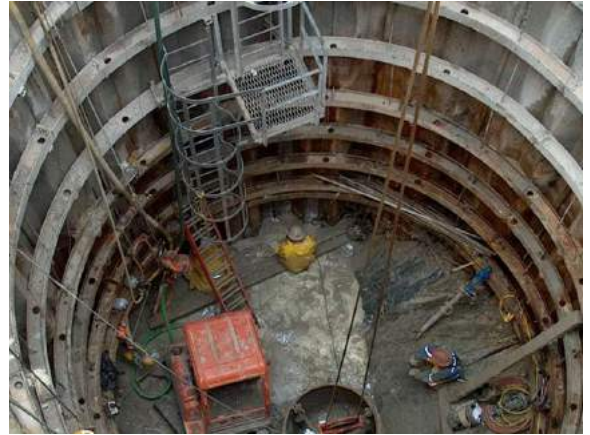
Sealing quicksand inflows at sheet pile – rock interface

Small diameter holes were drilled through the sheet piles about 50 to 75 cm above the bedrock interface and spaced about 10 cm apart using an electric drill with a magnetic base. Holes typically encountered flowing quicksand immediately after penetrating the steel sheet pile, so plastic injection packers were quickly installed to close the drill holes.

After drilling a horizontal line of drill holes over a distance of 1 to 2 m, approximately 2 to 4 liters of water-activated chemical grout was initially injected at each packer location.

The systematic process of packer removal, gradual deepening of drill holes and injection of additional chemical grout was undertaken until approximately 1 m of consolidated soil had been achieved beyond the sheet pile perimeter.

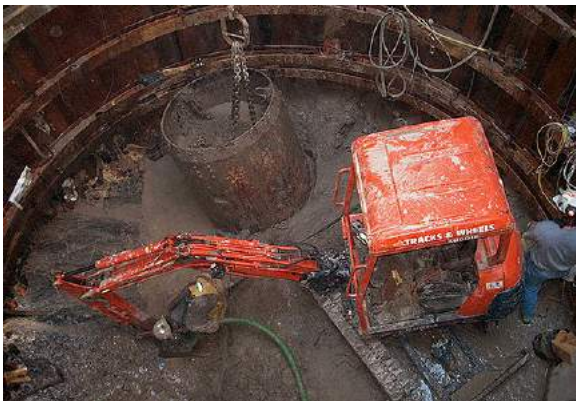
At this point, the contractor observed continuous inflow of quicksand and unsuccessfully attempted to use rags and wooden wedges to control these inflows. Shaft collar excavation work was at a standstill when the contractor called Peter White for assistance.

Quicksand inflow at the bottom of the shaft

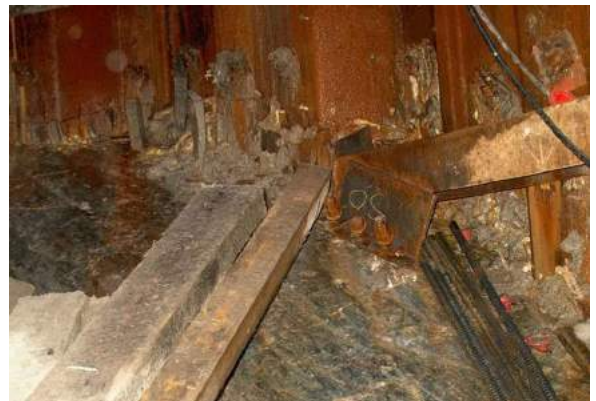
Sealed sheet piles at bedrock contact

After 10 days of chemical grouting work that consumed over 1,500 kg of chemical grout, all of the shaft bottom had been excavated down to solid rock with no further water infiltration.
